# MARINE STRUCTURES

## THEIR DETERIORATION AND PRESERVATION

REPORT

COMMITTEE ON MARINE PILING INVESTIGATIONS  
*of the* DIVISION OF ENGINEERING AND INDUSTRIAL  
RESEARCH *of the* NATIONAL RESEARCH COUNCIL

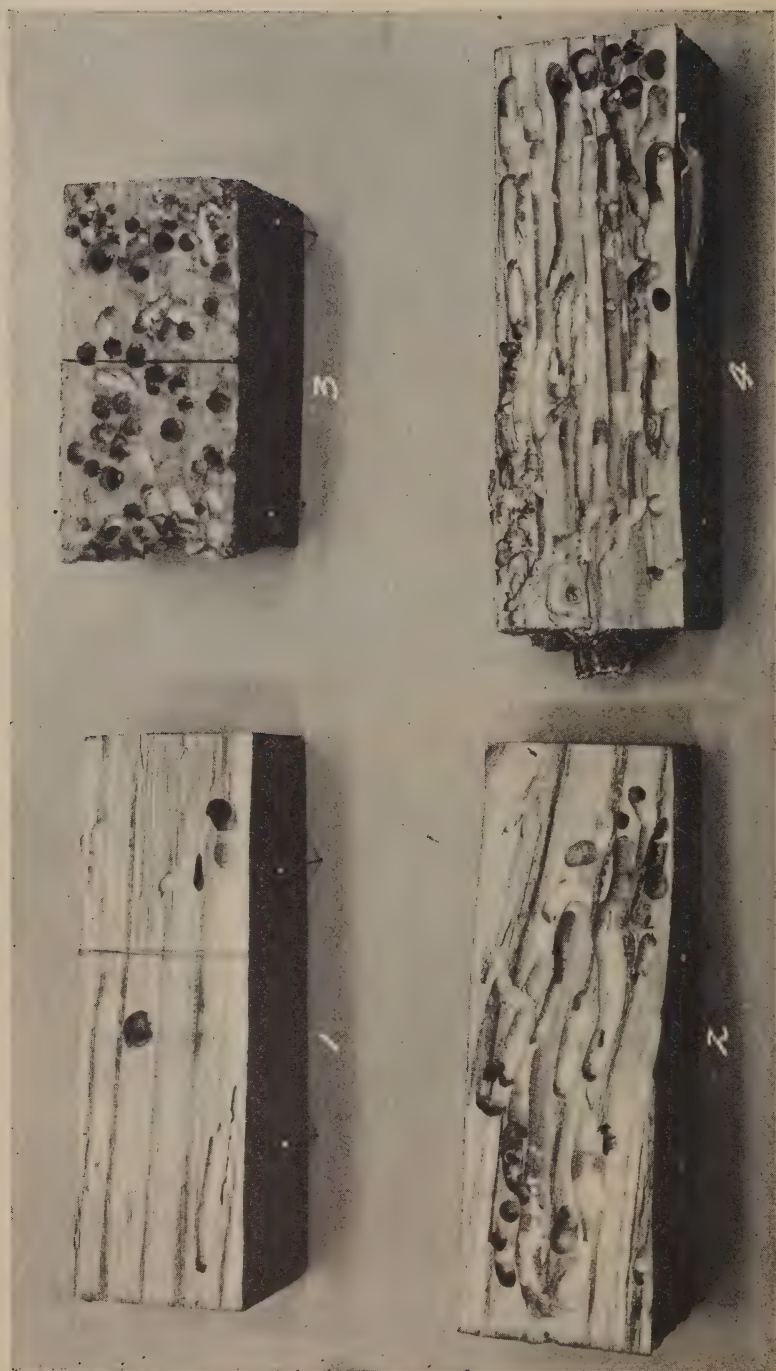
FIG. 4—SECTIONS OF BLOCKS FROM NEW HAVEN & HARTFORD R.R. TEST BOARDS INSTALLED JUNE 1, 1922.

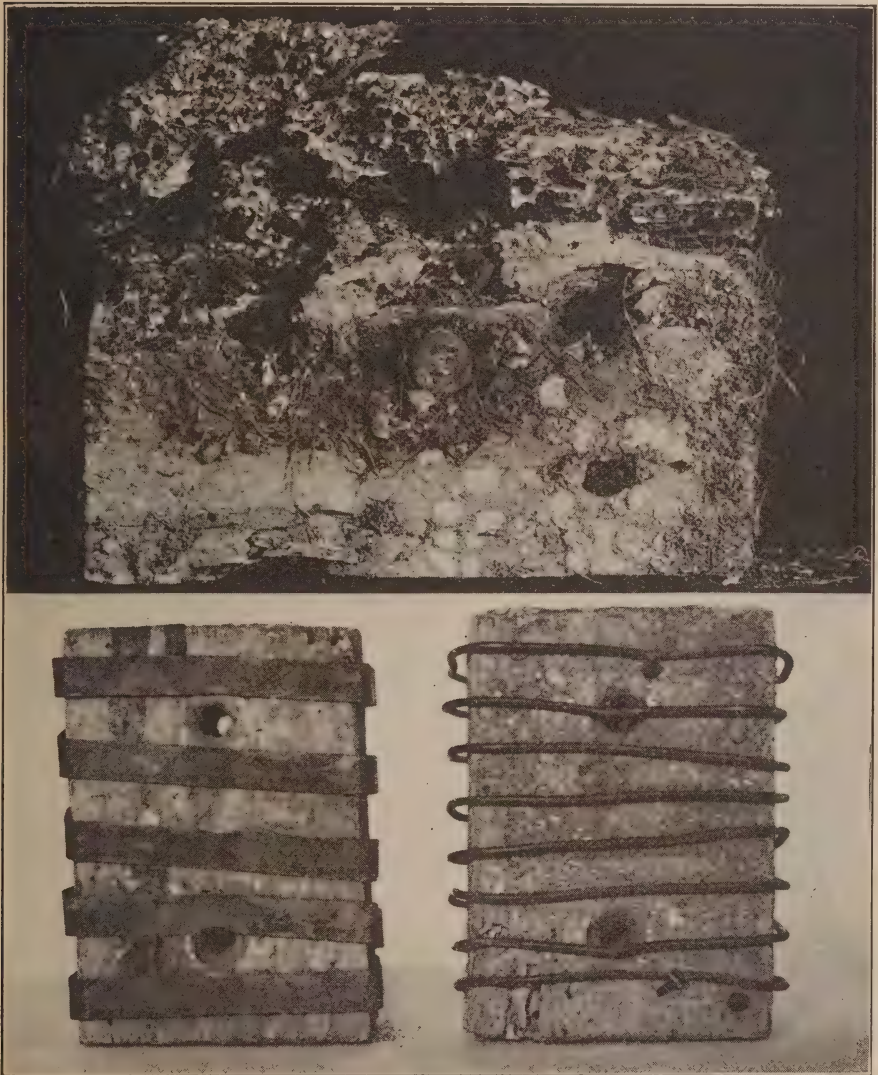
When these blocks were removed after this three months' period it was found that the copper had slowed up the destruction very appreciably (Fig. 6), and that the strips were more effective than the wire. The animals in both the bound blocks appeared to be dead, while those in the unbound block were many of them alive. On account of this encouraging result, eight test boards were prepared by the U. S. District Engineer at Charleston, S. C., and immersed at Castle Pinckney, where the attack was known to be heavy. These blocks were bound with  $\frac{1}{2}$ -in. copper strips and with wire spaced from  $\frac{1}{2}$  in. to  $2\frac{1}{4}$  in., varying by  $\frac{1}{4}$  in., with every third block unprotected as a control. Seven sets of blocks were mounted on galvanized bars and the eighth on a palmetto pole. The blocks from these boards were removed periodically as in the case of the standard boards.

FIG. 6—TESTS OF COPPER WIRE AND BANDS, CHARLESTON, S. C.  
BOARD SUBMERGED SEPTEMBER 6, 1922

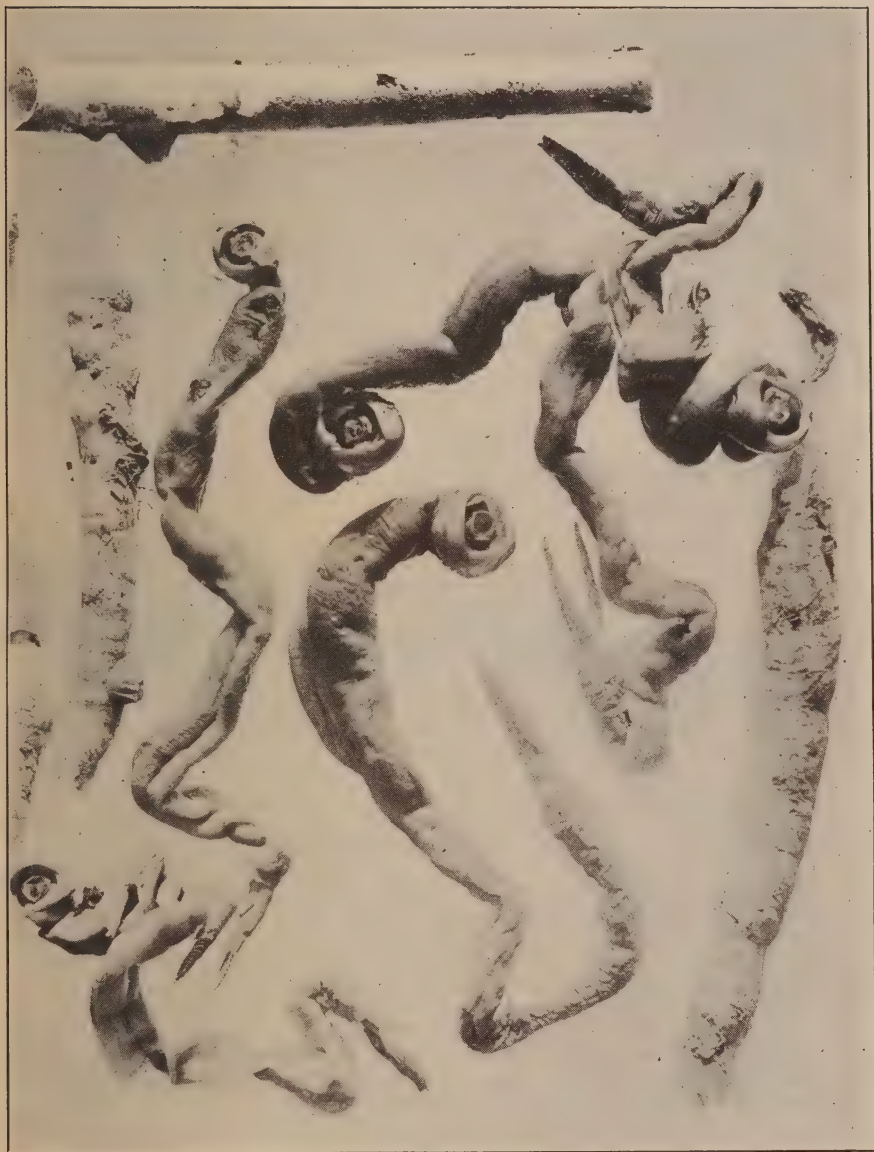
FIG. 15—SPECIMENS OF *Bankia* REMOVED FROM BURROWS WITH SECTIONS OF THE BURROW CASINGS.

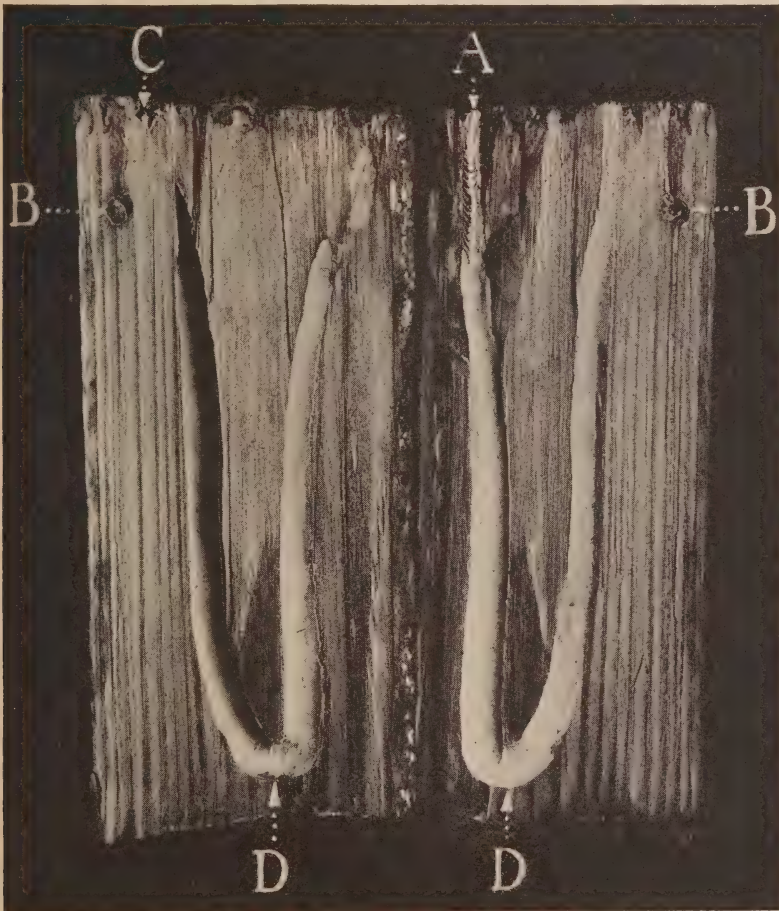
FIG. 16—*Bankia setacea* 12 INCHES LONG IN TEST BLOCK FROM COOS BAY, ORE. BLOCK PLACED JUNE, 1921; REMOVED OCTOBER, 1922.

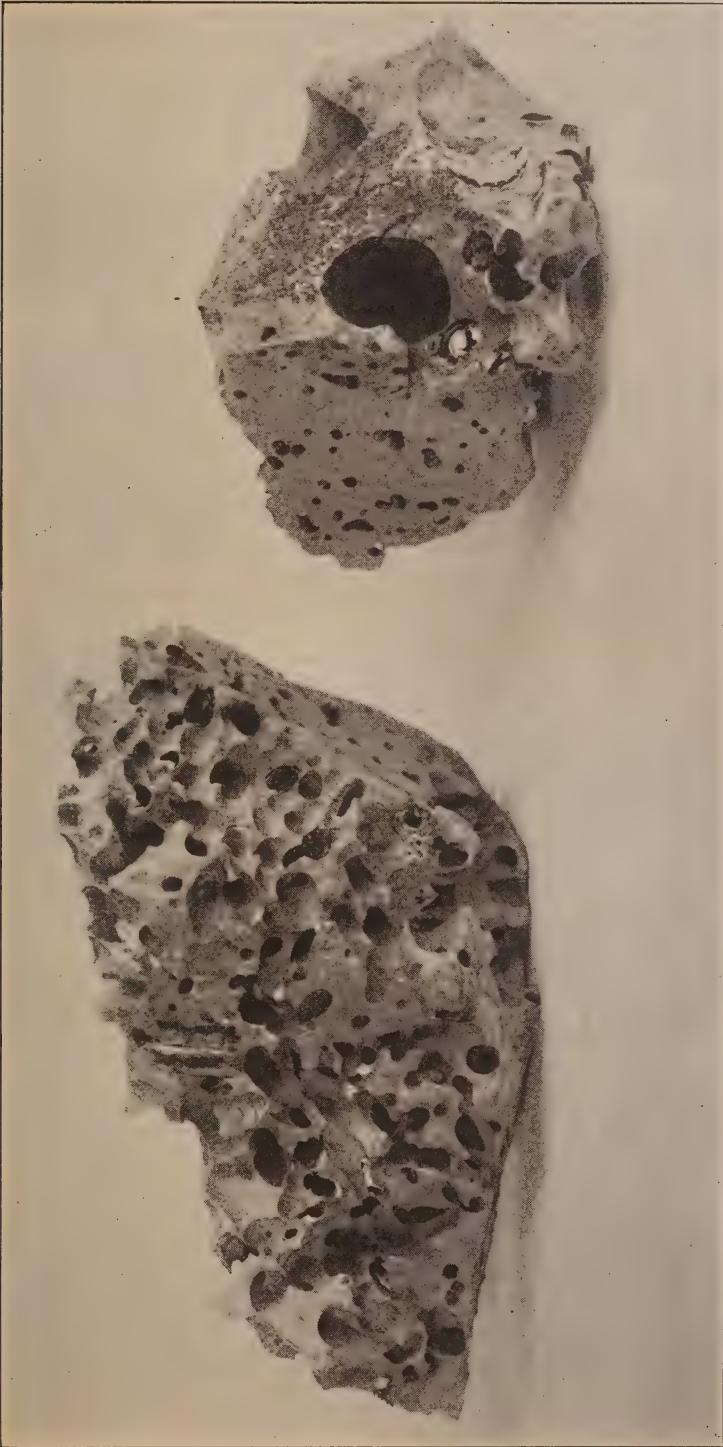
FIG. 17—SPECIMENS OF STONE FROM RIP-RAP AROUND WEST RIGOLETS LIGHTHOUSE, LA., PERFORATED BY BORERS — *Lithophaga* (*Dulerus*) *Bisculata* ORBIGNY AND *Gastrochaena Ovata* SOWERBY

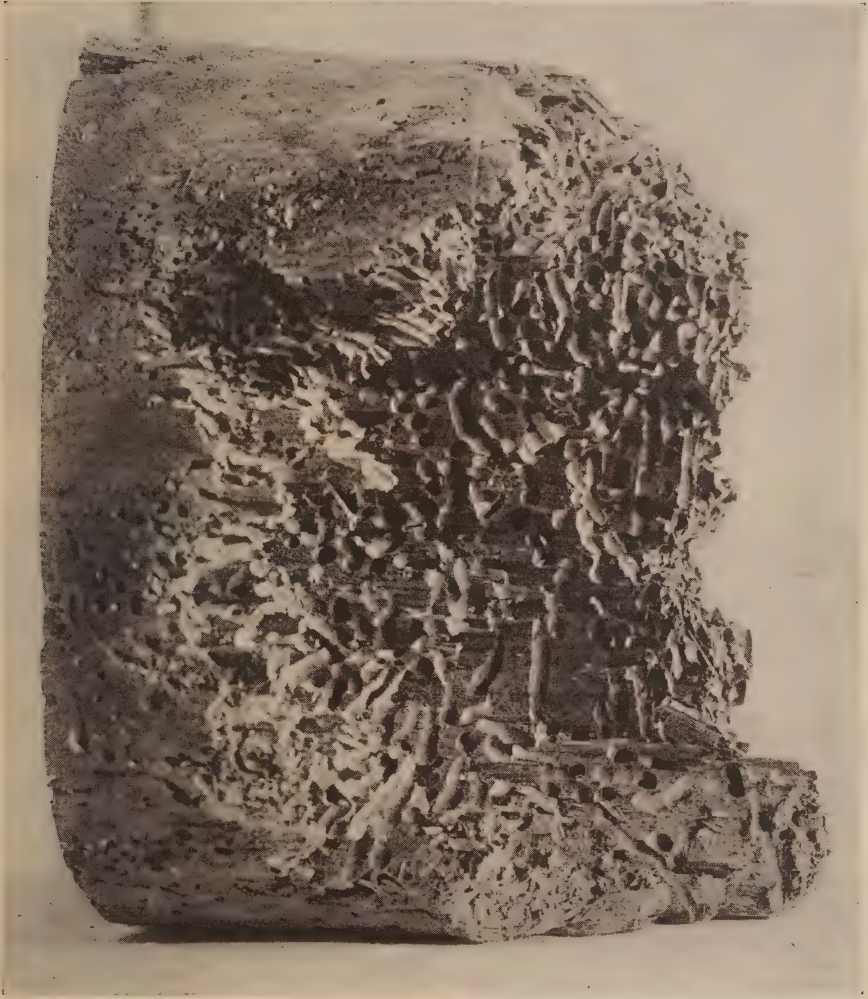
FIG. 19—SECTION OF JUCARO PILE FROM DOLPHIN OF TEXAS OIL COMPANY,  
MATANZAS, CUBA

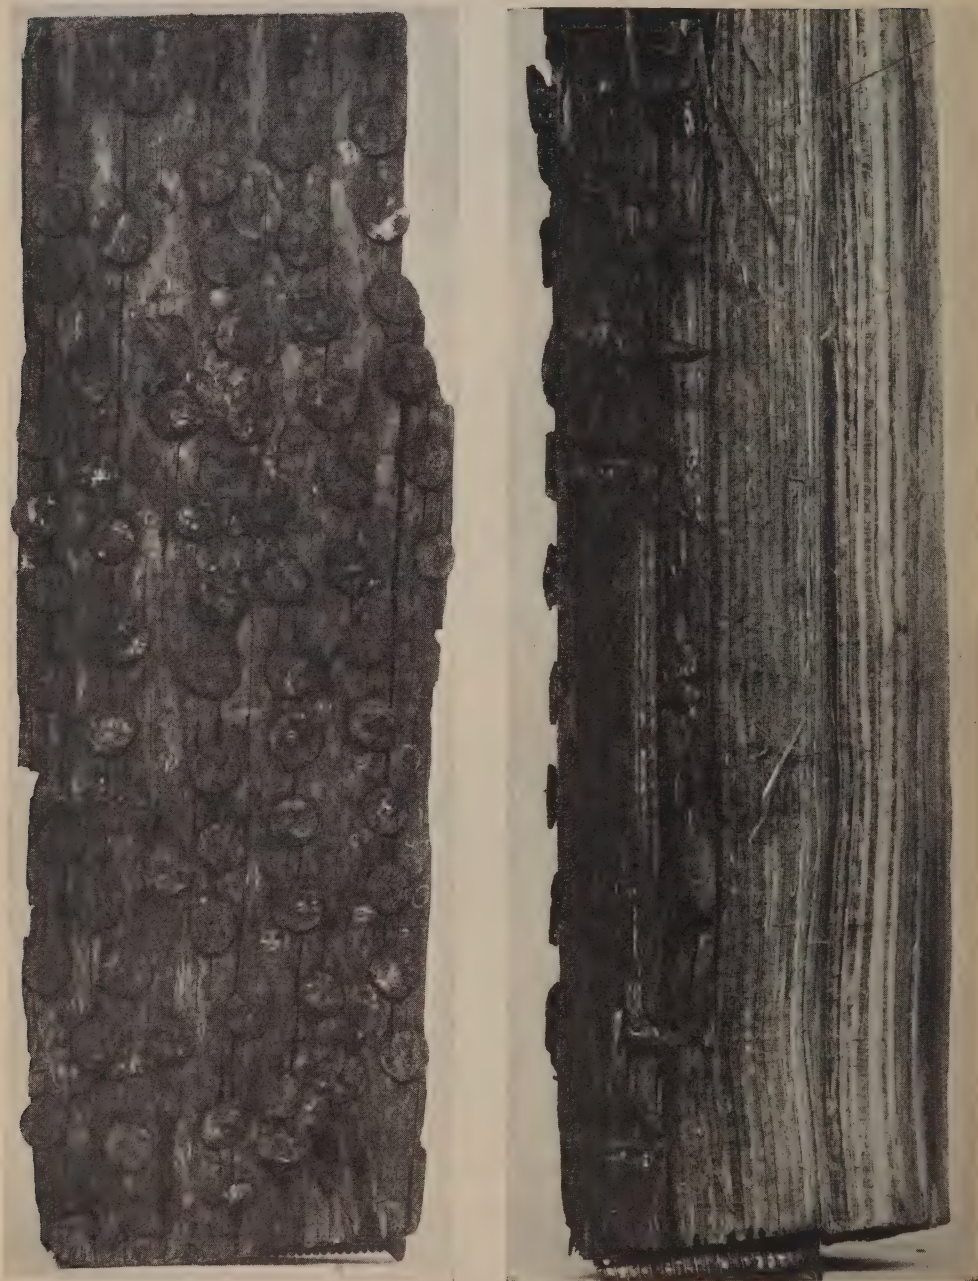
FIG. 22—SECTIONS OF PILE FROM WHARF OF THE CHARLESTON DRY DOCK  
AND MACHINE CO., CHARLESTON, S. C., WITH 4 YEARS' SERVICE

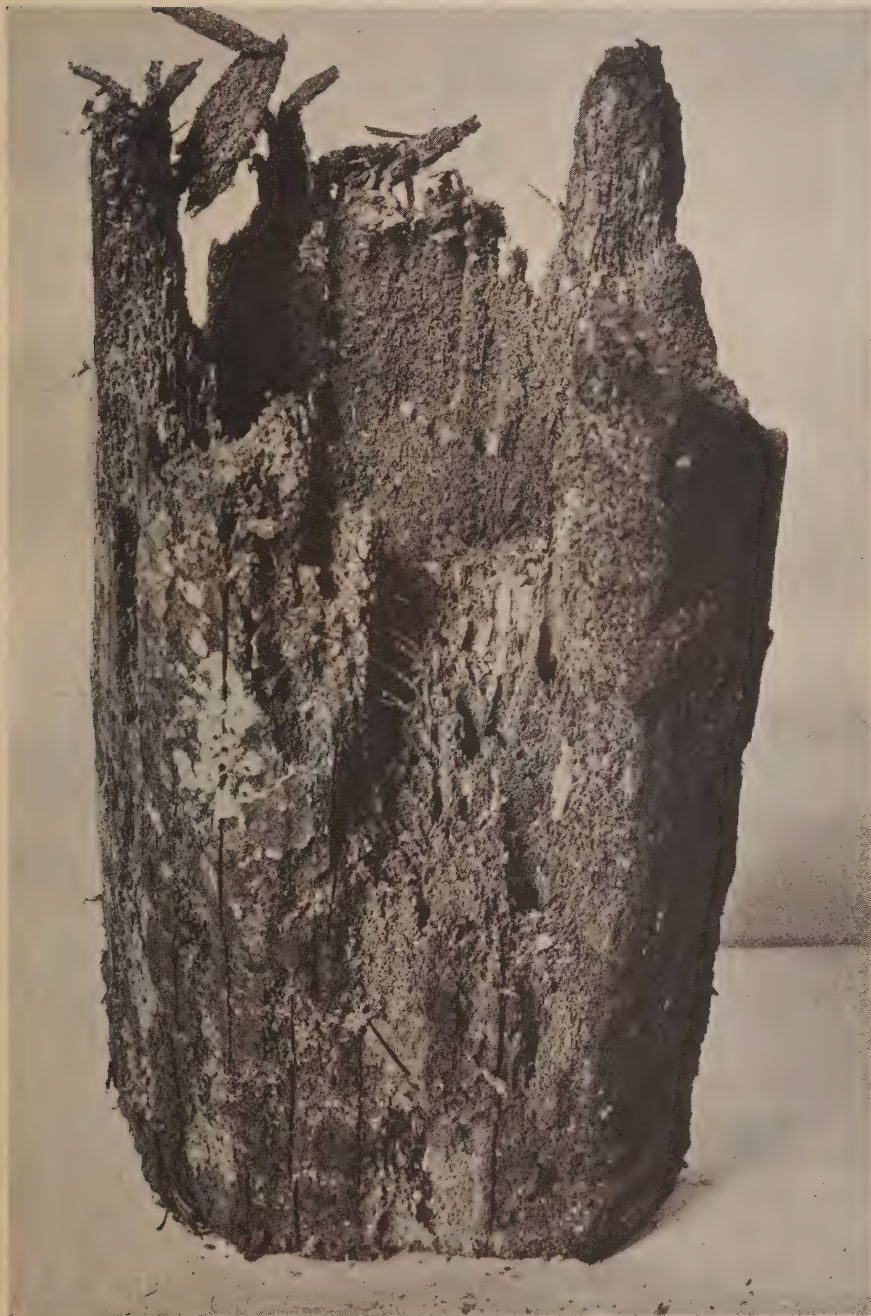
FIG. 27—SECTION FROM CREOSOTED PINE PILE—16 LB. TREATMENT—U. S. NAVAL STATION, ST. THOMAS, V. I.

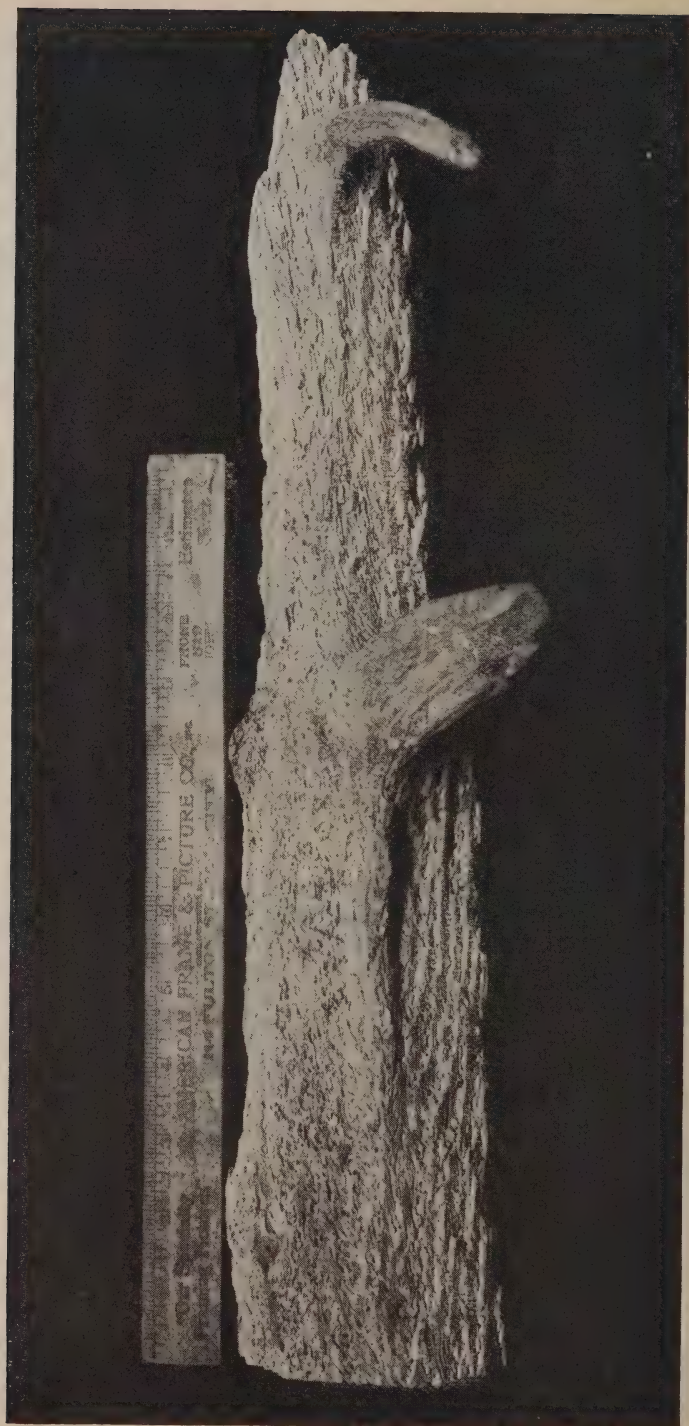
FIG. 42.—SECTION OF PILE DRIVEN IN GRAND TRUNK RY. PIER AT PORTLAND, MAINE, SHOWING *Limnoria* ATTACK. PIER DESTROYED BY BORERS

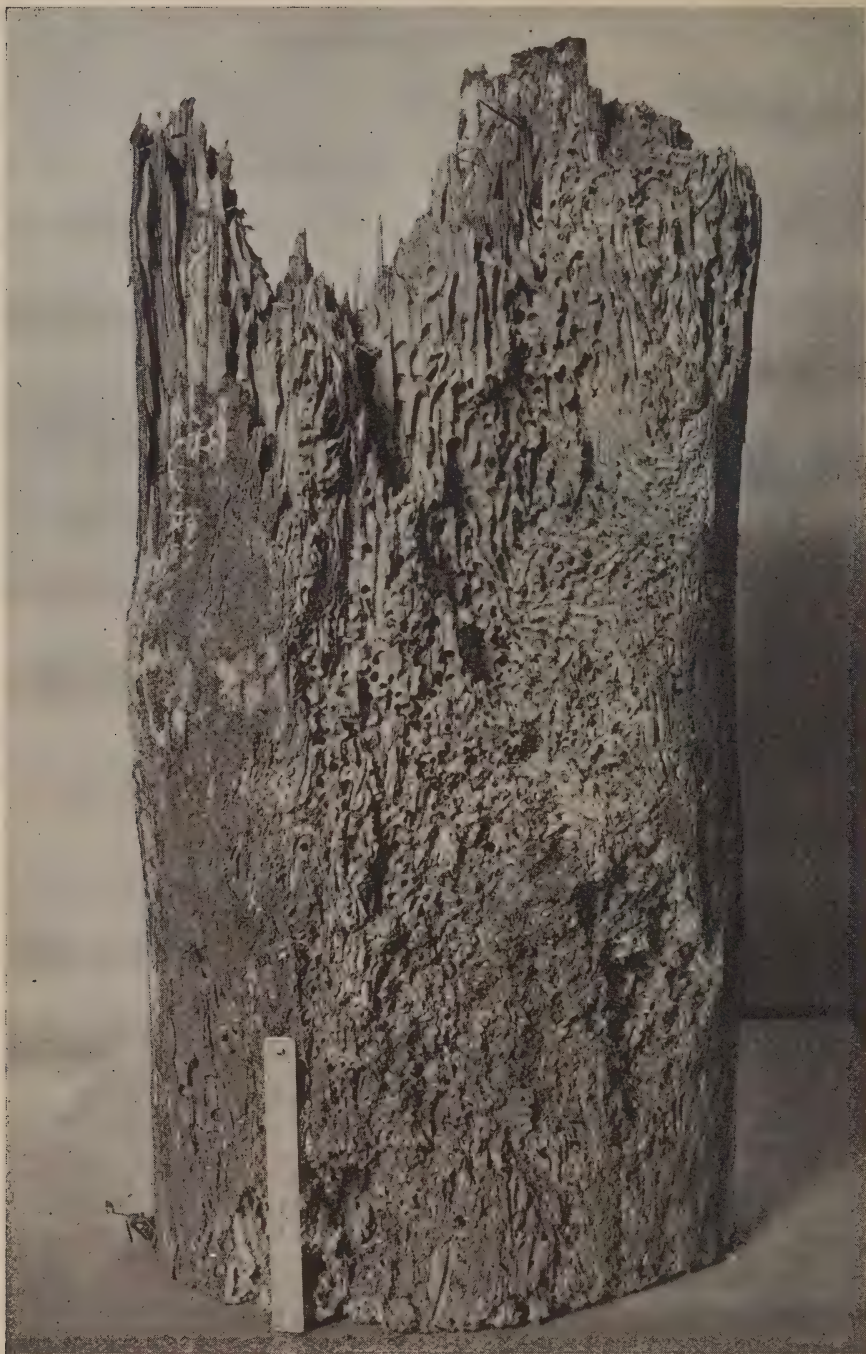
FIG. 64—UNTREATED PINE PILE, U. S. N. SUBMARINE BASE, NEW LONDON, CONN.  
Driven, 1918—Removed, 1923.

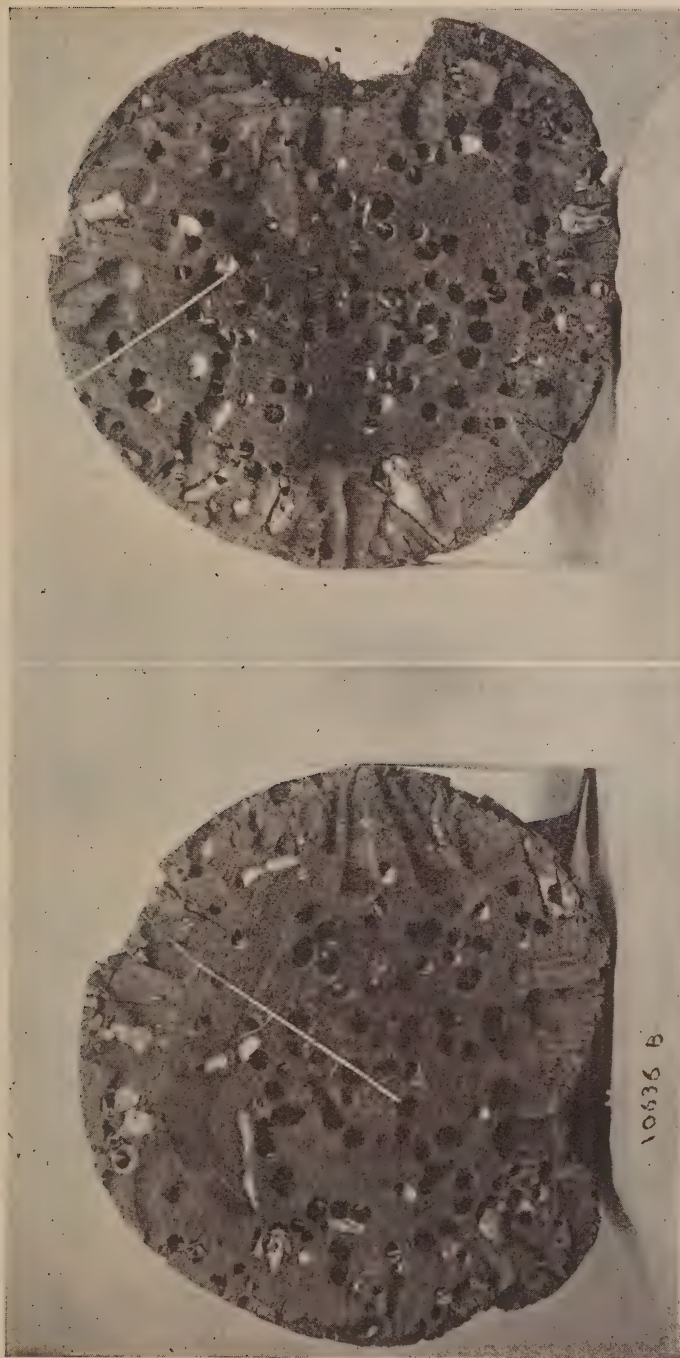
FIG. 114—SECTION OF UNPROTECTED PINE PILE WITH ONE YEAR'S SERVICE AT THE MOUTH OF THE MANATEE RIVER, TAMPA BAY. ATTACKED BY *Bankia* AND *Martesia*.
